The Newcastle Earthquake and the Masonry Structures Code AS3700

Adrian W. Page¹

Abstract

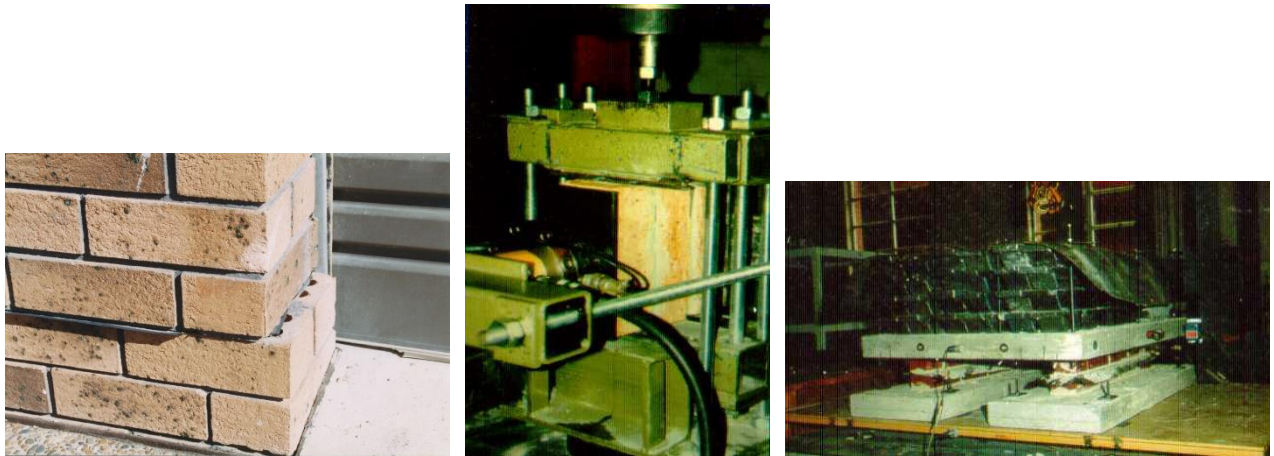
Most unreinforced masonry structures have joints which incorporate some form of membrane, to act as a flashing, damp-proof course (dpc) or a slip joint (to allow relative movements between the masonry and other structural elements such as concrete slabs). In the Newcastle earthquake, sliding was observed in some of these joints, confirming their limited frictional capacity. From an earthquake design perspective, these joints will often form part of the load path necessary to transmit the induced earthquake forces, so that knowledge of this limited frictional capacity is important. As a consequence, as shown in Figure 5, a comprehensive series of static and dynamic shear tests on masonry joints containing a range of different membrane materials was performed at the Universities of Adelaide and Newcastle (Page 1995, Page & Griffith 1998). Subsequently a table of design shear factors for a range of joint types (with or without a dpc membrane) were incorporated in AS3700 (Table 1).

Figure 5. Static & shaking table tests on masonry joints (Page)

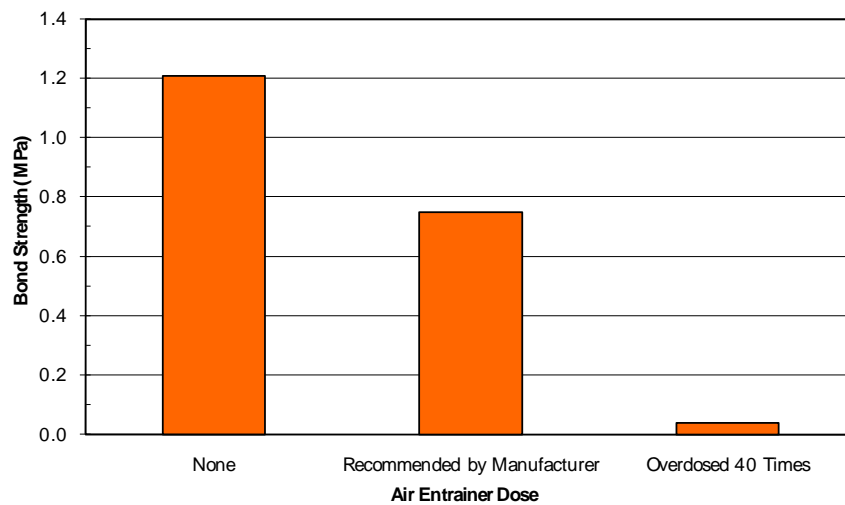
As previously described, there was widespread evidence of poor masonry bond strength in both new and old construction. Subsequent research indicated that the prime cause of the bond strength reductions was the lack of adherence to the AS3700 mortar requirements, and in particular, the use (and overdosing) of plasticising agents such as air entrainers or fire clay (Sugo et al. 1996). Figure 6 shows the results of a Newcastle bond study on the influence of air entraining agents on bond strength (note that field observations revealed overdosing rates up to 40 times the recommended level). In-depth studies of the influence of other supplementary cementitious materials on bond strength were also carried out (Lawrence et al. 2008), with the outcomes being reflected in the revised masonry standard.

Figure 6. The influence of air entraining agents on masonry bond strength (Sugo et al.)
