# Seismic Upgrade of Heritage Masonry – A Case Study of St Peter’s Cathedral in Adelaide

**Keywords:** Heritage construction; seismic retrofit; historical stone masonry

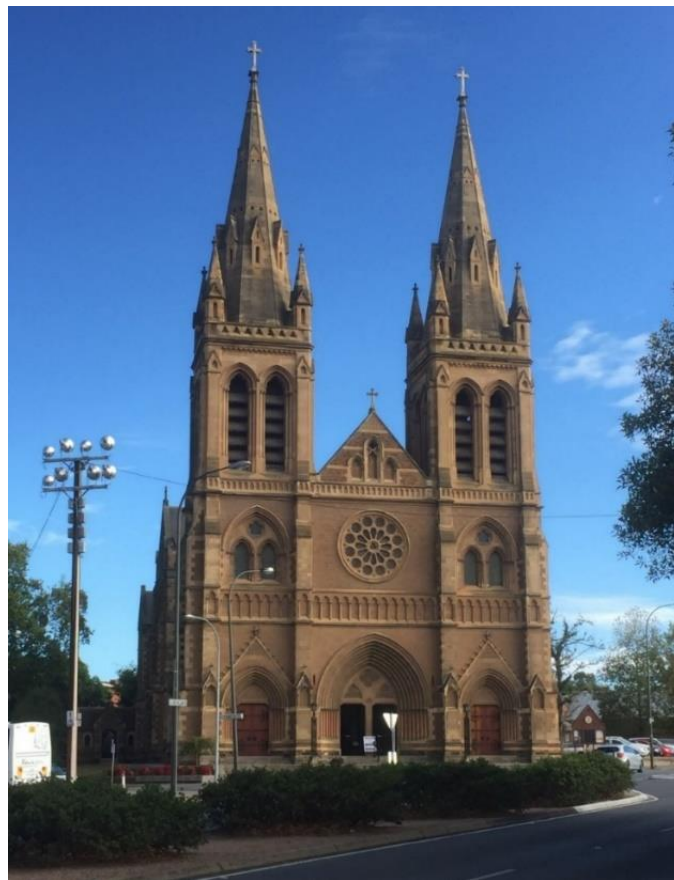
Figure 1: St Peter's Cathedral as it stands in the present day (south-east elevation).

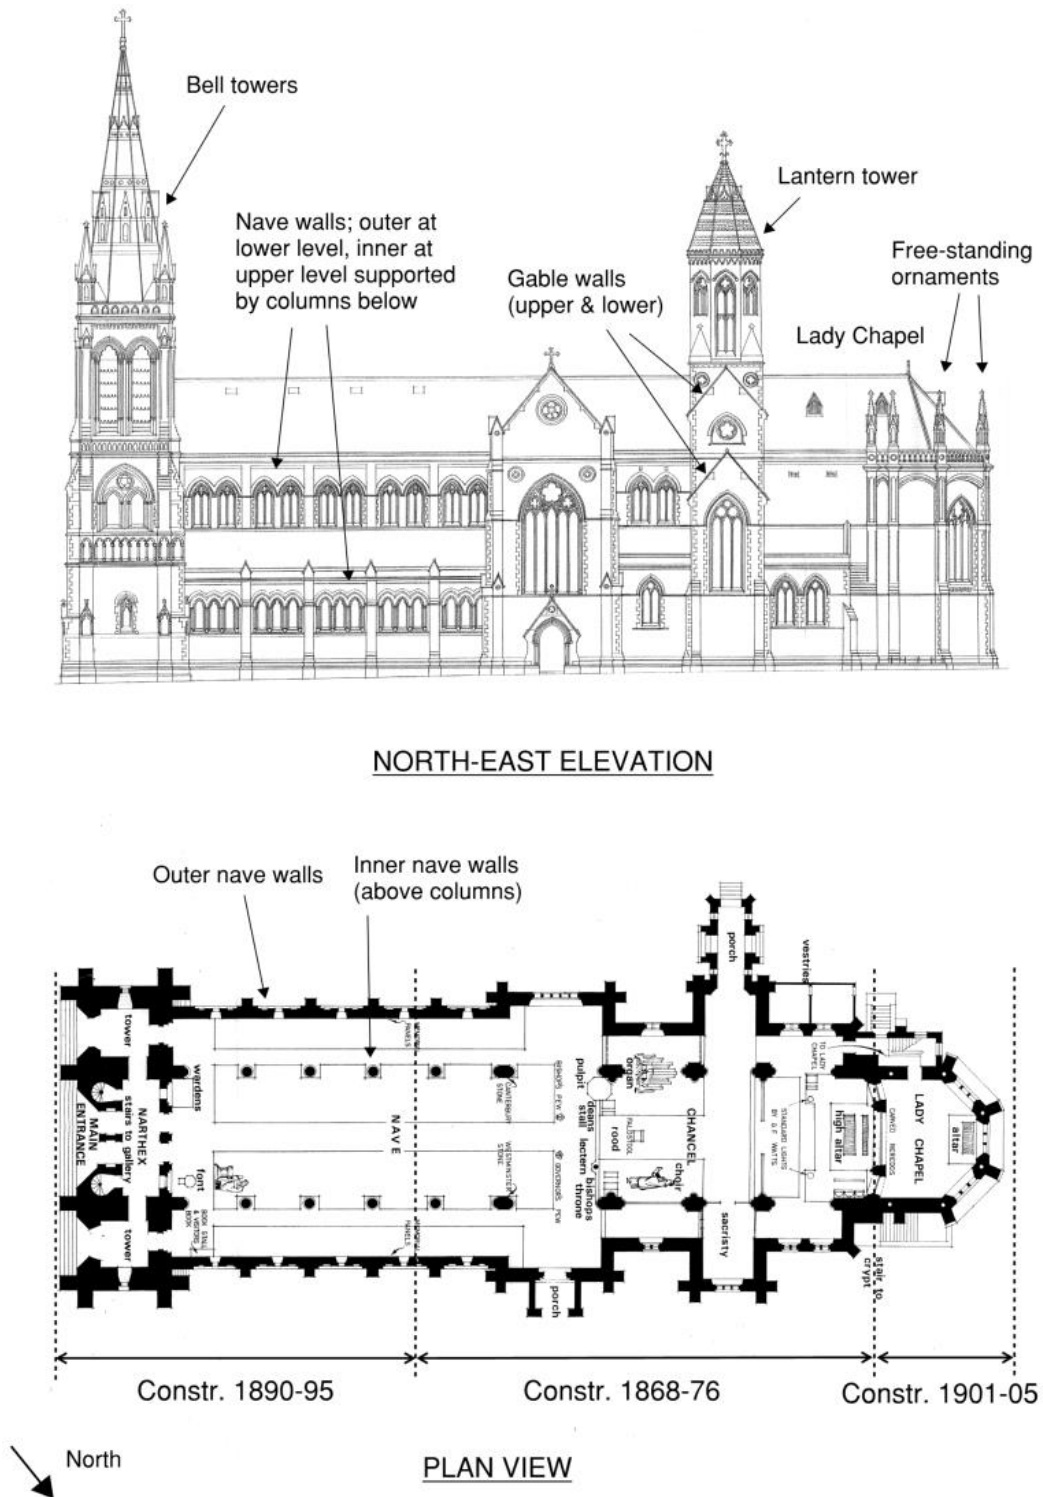
As noted earlier, access to the structure was dictated by the roof repair work being conducted to stop water ingress. Hence, to date, the seismic strengthening work has only focussed on items to which access was available as a consequence of the other works. This includes stabilisation of two of the gable end walls adjacent to the lantern on the south-west face of the cathedral and stiffening of the Lady Chapel roof structure to improve horizontal diaphragm action for improved out-of-plane stability of the side walls (refer Figure 3). These are discussed in more detail below.

Figure 3: Plan and longitudinal elevation of St Peter's Cathedral
