Structural Monitoring of Bumbu and Butibam Bridges of Lae City, Papua New Guinea

¹Grace Wantepe and ²Mirzi L Betasolo*, ³Nicholas Lambrache
Department of Civil Engineering Papua New Guinea University of Technology
¹grace.wantepe@pnuot.ac.pg
³nicholas.lambrache@pnuot.ac.pg

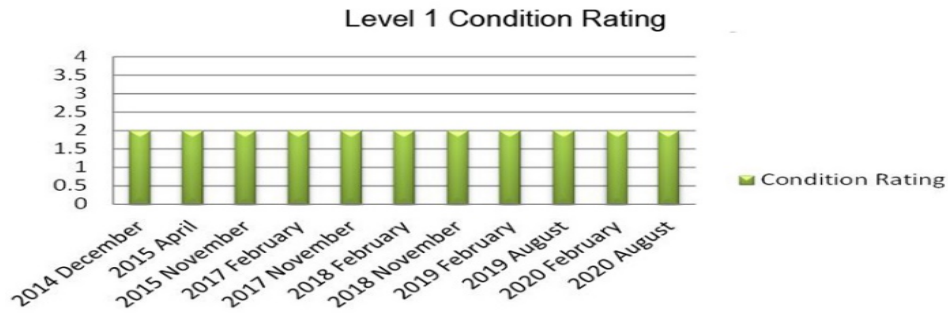
Figure 11: Level 1 - Butibam Bridge Overall Structure Condition Rating from December 2014 to August 2020.

As mentioned earlier, the level 1 monitoring was conducted at a frequency of 6 months, and from the results presented, it can be noted that the bridge condition is generally good throughout monitoring except for minor maintenance and repair of road approaches and guard fencing or railings.

The graph in Figure 11 shows the summary of the Level 1 overall condition rating for Butibam during the period of inspection and assessment from December 2014 to August 2020. During that period of inspection and assessment, it was noted that the results improved when there was a repair and maintenance of the miscellaneous components. It was also concluded that these maintenance practices can have an impact on the overall bridge structure condition rating. The overall condition rating for Butibam Bridge was below 2 during the assessment period, as shown in Figure 12, Level 2 SGBCA Result for Butibam Bridge on 10th December 2014. This result shows that only a slight deterioration or damage was done to the Bridge except for minor routine maintenance, repair, and replacement works.

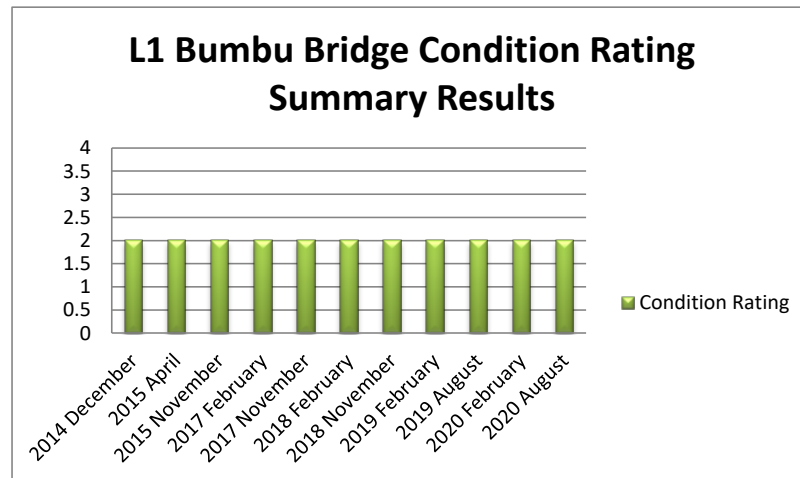
Figure 18: Summary Results for Bumbu Bridge Level 1 Condition Rating

The graph below shows the results of level 1 routine inspection and condition assessment between December 2014 and August 2020 at Bumbu Bridge. The

overall bridge structure condition rating is 2. Some maintenance work is required for minor repairs, including non-loading bridge elements.

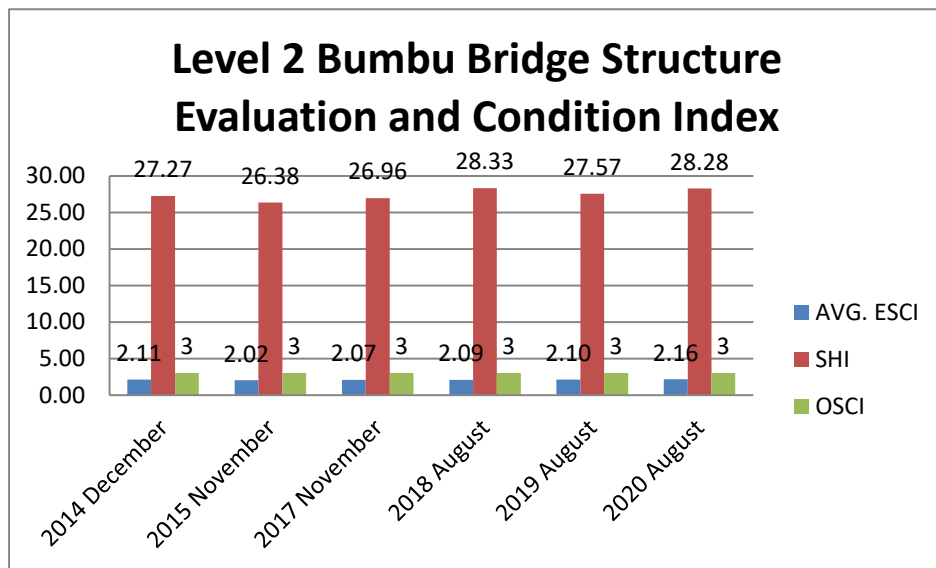
Figure 20: Graph showing the summary of the condition index of the Bumbu Bridge

According to the inspection and condition assessment results, Bumbu Bridge had an average ESCI value of 2 for all years of inspection, a low SHI of 26.38, and a high SHI of 28.33. However, an OSCI is 3, which means that the Bridge requires further attention to evaluate its structural integrity, repair, and maintenance requirements. All Level 2 bridge structure evaluations and condition assessment results for Butibam Bridge from December 2014 to August 2020 are shown in Table 4, Level 2 SGBCA Evaluation of the Overall Structural Condition Index (OSCI) for Bumbu Bridge.
