# Seismic Resistance of Brick Veneer Under Face Loading

Stuart J. Thurston<sup>1</sup> and Graeme J. Beattie<sup>2</sup>

## Abstract

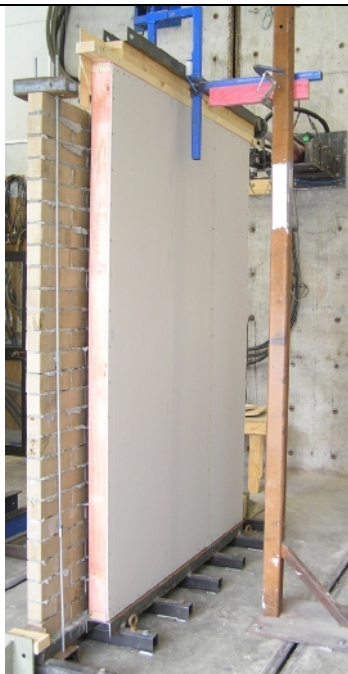
**Figure 1. Test set-up for in-plane racking tests**

The walls were slow cyclically racked in the in-plane direction (Figure 1) before performing shake tests in the out-of-plane direction. The wall framing was fixed to preclude stud uplift. The wall frame was lined with plasterboard for the in-plane tests but this was removed for the out-of-plane shaking tests as it provided no contribution to the strength and little inertial mass.

For the in-plane tests, an actuator applied four cycles of  $\pm 24$  mm top plate displacement to each framed wall with the brick veneer precluded from rocking, and then four cycles to  $\pm 36$  mm with the rocking restraint removed. The veneer walls cracked at opening corners and at the base of the wall.

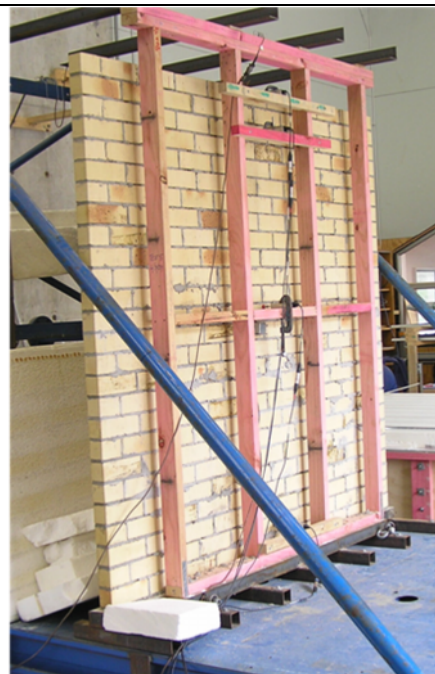
**Figure 2. Test set-up for out-of-plane shake table tests**

The bottoms of the specimens were bolted to the shake table as shown in Figure 2. The top of the wall framing was constrained to move in concert with the base of the wall. Thus, the accelerations imposed on the table were also (approximately) the same as imposed at the top of the framing. This simulated the situation where the side walls and ceiling/roof diaphragm of a house are extremely rigid. To check whether side wall and diaphragm flexibility would result in a more severe loading on the veneer, in one test (Wall W6) a

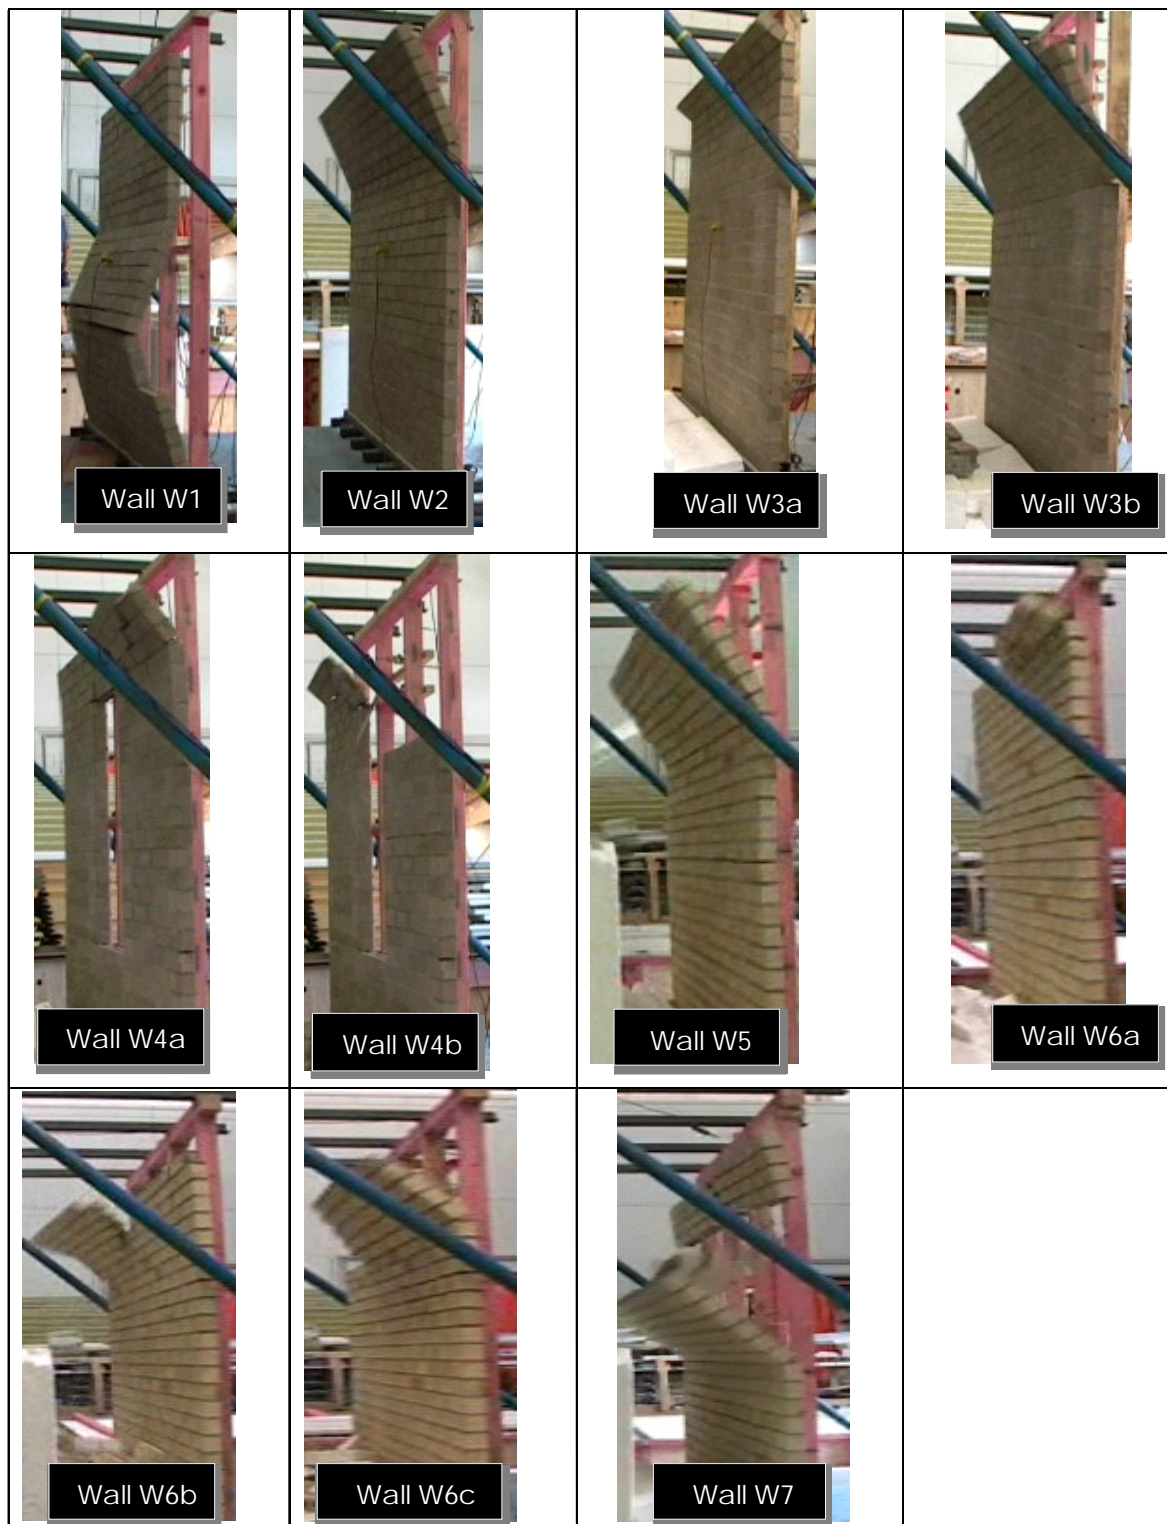
**Figure 5. Photographs of veneer collapse mechanisms for each test**

The third column of Table 4 describes the wall failure mechanisms and Figure 5 shows photographs of veneer shedding. In five of the seven walls the top portion of bricks toppled in a cantilever action. Subsequent shaking resulted in further layers falling from the top. In the other two walls (Wall W1 and W7) the veneer collapse occurred in the body of the veneer.

In all instances veneer shedding was due to tie failure. Generally this was preceded by full tie pullout from the mortar, although occasionally the ties partially pulled out under tension, jammed and then buckled under subsequent compression load and then finally ruptured. In two instances (Wall W5 and W7) stud rupture and shear failure of stud-to-top plate joints occurred before the veneer collapsed. These LTF failures were repaired and the testing continued until veneer shedding occurred.

Before the out-of-plane shaking had commenced on Wall W3, it was noted that a crack had formed in the second mortar joint from the top (where the ties were embedded), possibly from the in-plane cycling. The top two courses rocked from the first stage of loading and toppled during the first testing at 3Hz (see the photograph for Wall W3a in Figure 5). The test continued on this wall until a second veneer collapse occurred (Wall W3b in Figure 5). The spectra before this second collapse were far higher than that for the first collapse.

corresponding to the top and bottom of the window passed through the tie locations. At the top of the window, ties were accidentally placed under the steel angle lintel seating which meant they were not bonded. This resulted in a relatively early failure of the top four courses (falling at 2Hz shaking). At shaking levels only slightly greater, other layers of veneer peeled off the top (see Figure 5).

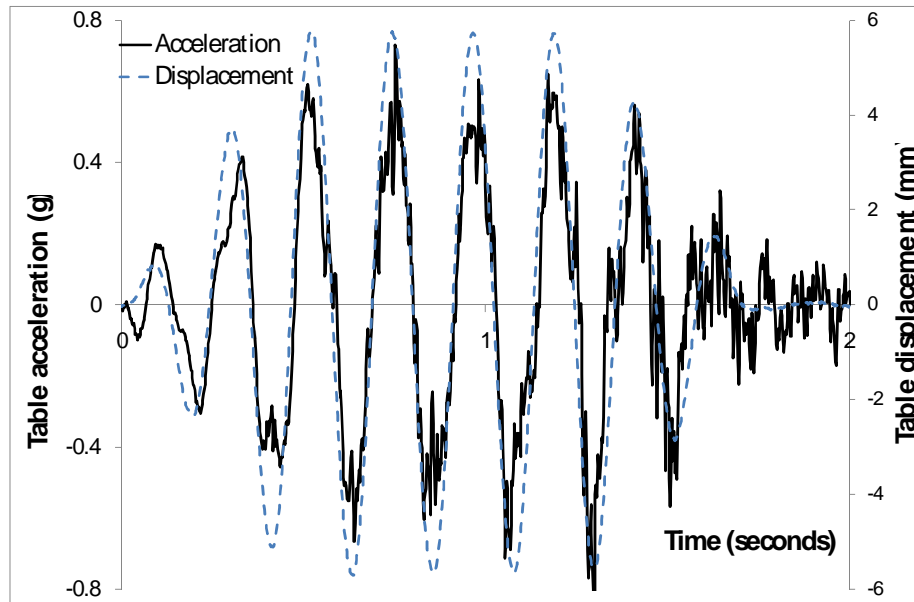
**Figure 6. Typical plot of table displacement and acceleration in shake table tests**

The applied table displacements were a smooth sinusoidal record as shown in Figure 6. However, due to friction effects the table accelerations were a rougher signal. The acceleration records were used to compute acceleration spectra and an envelope of such spectra from tests before that causing failure was computed for each wall. The spectra presented herein were derived for 5% damping as this is what was assumed when the NZS 1170.5 (SNZ, 2004) design spectra were derived.

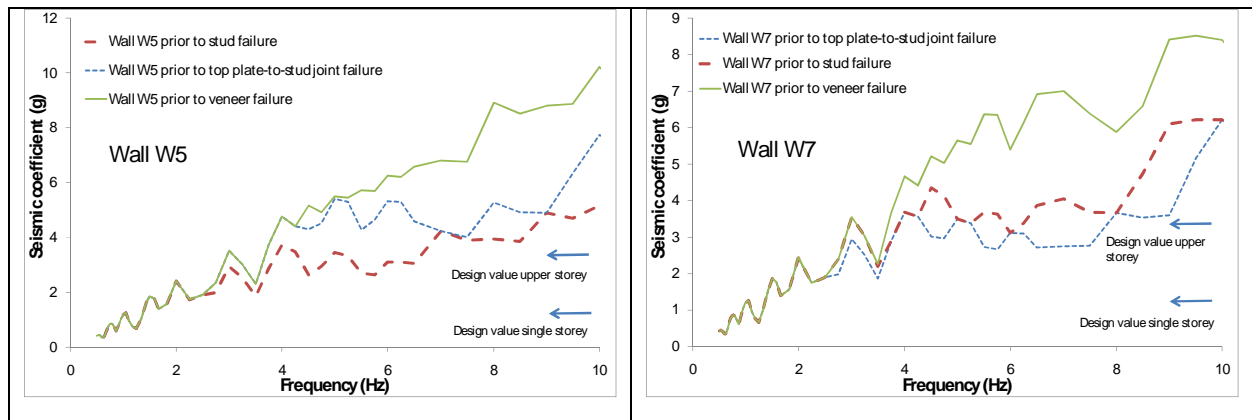
**Figure 9. Spectra for Walls W5 and W7 for shaking prior to timber failure and veneer failure**

Figure 9 gives the spectra when timber framing failures occurred in Walls W5 and W7. These failures were well in excess of the design values for single-storey construction.
