Australian Earthquake Engineering Society 2012 Conference, Dec 7 - 9, Gold Coast, Qld

The Impact of the Canterbury Earthquake Sequence on the Engineering Profession in New Zealand

Dave Brunsdon^{1,2}, John Hare^{1,3} and Mike Stannard^{1,4}

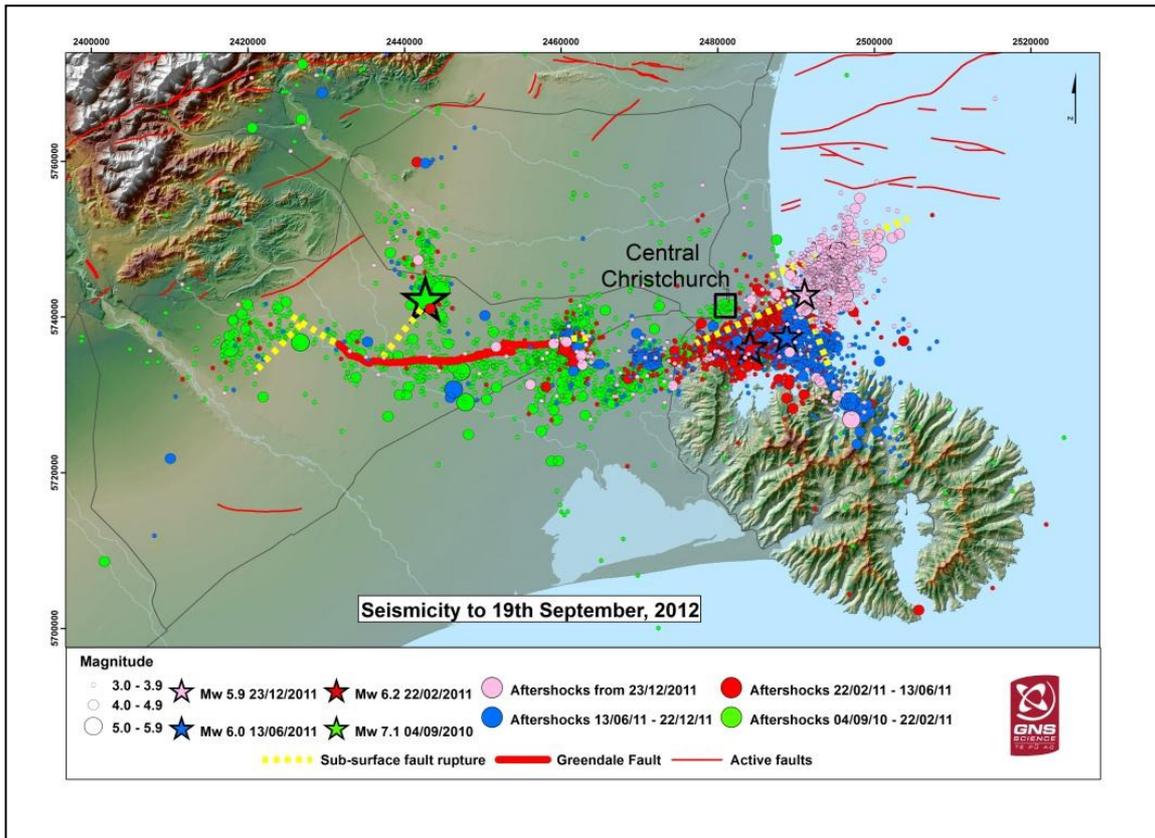
Figure 1: Seismicity Plot to 19 September 2012

In total, more than 50 earthquakes of greater than M_5 have been recorded in this sequence, the most recent being on 25 May 2012. The overall plot of aftershocks up until 19 September 2012 from GNS Science is shown in Figure 1, grouped in relation to the above principal aftershocks.

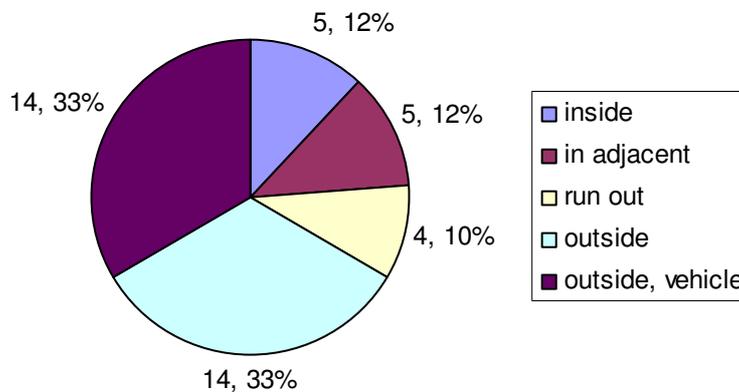
Figure 2: Deaths from building failure (excluding CTV and PGC) (EAG, 2012)

An interesting finding from the analysis of the 42 lives lost in relation to URM buildings was that only 5 people died within the buildings that failed (EAG, 2012). The lives lost were principally due to people either running outside or being directly outside (several in vehicles), and being crushed by falling masonry parapets and facades – refer to the analysis in Figure 2. There were very few instances of URM buildings completely collapsing, except those with no internal wood-framed structure.
