# Earthquakes and historical buildings — it isn't all bad news

Bill Jordan, FIEAust CPEng

Bill Jordan & Associates Pty Ltd, Newcastle, NSW

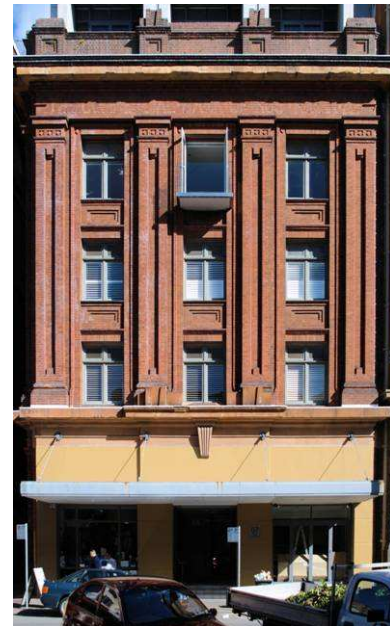
**Figure 1: Typical undamaged building in Newcastle**

Many of the buildings to which I refer, such as that seen in Figure 1 in which not even a hairline crack was found, despite it being in an MMVI to MMVII area, were well built and did not have laterally unsupported elements such as tall parapets and gables; neither did such buildings have soft understoreys, even though some were certainly less stiff in the commercially-oriented ground floors compared to the upper floors which had many small rooms. However, the lack of or very minor cosmetic damage suggests other factors which have not been properly explored:

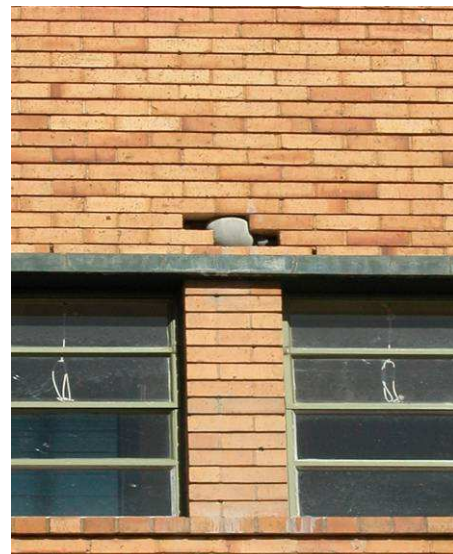
Figure 4: Bricks removed to demonstrate expanded grout sock

A project with similar heritage constraints in which the author was involved was the seismic strengthening of Adelaide High School where, again, heritage considerations precluded any alteration to the appearance of the external brickwork or the internal wall finishes. In this case the cavity brickwork external walls were strengthened by grouting anchors into the wall cavities to form a series of reinforced bands: the walls were then connected within the roof space by hidden steel framework (see Figures 3 and 4.).

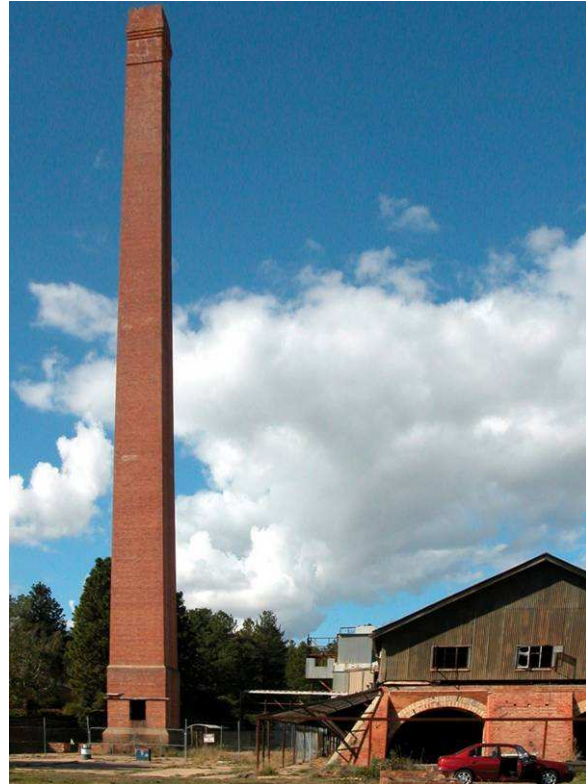
**Figure 5: Stack S3 at Yarralumla. The new townhouses are behind the fence on the left.**

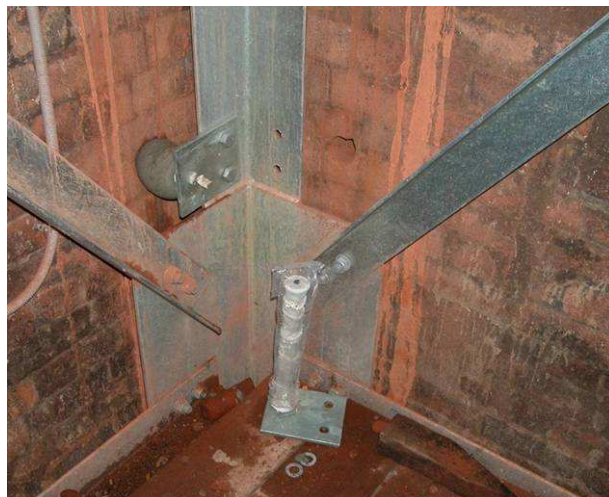
**Figure 6: Composite attachment of frame to brickwork using cantilevered SHS anchors**

The problem was solved by using a cementitious masonry anchor with moment capacity which allowed the frame to be up to 120 mm away from the brick face. In Figure 6 the steel frame at one panel point can be seen with one

anchor fitted and the other about to be. The work, which included rock bolting the base of the frame to a depth of 6 m was successfully completed without scaffolding. All steelwork was carried in through an opening near the base of the stack and the angle sections used were able to safely carry scaffolding planks as the frame rose. Once the frame was completed the anchors were installed and bolted to the frame.
