Seismic Performance of a Brick Veneer Steel-Framed House

Vidal P. Paton-Cole¹, Emad F. Gad², Charles Clifton³, David J. Heath⁴, Carl Davies⁵,
Stephen Hicks⁶ and Nelson Lam⁷

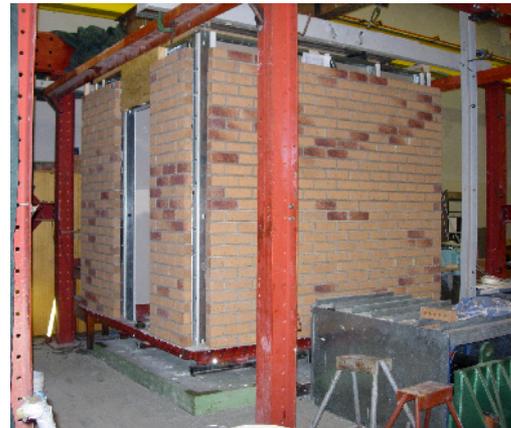
(b) Completed Test specimen

Figure 1. Test House geometry

The Test House was designed such that it encompassed a range of typical geometric features in the veneer walls in two different directions. It had two brick veneer walls without openings in one direction and in the orthogonal direction it had one wall with a window opening and the other wall with a door opening. Since the primary objective of the test was to examine the out-of-plane performance of the brick veneer walls, the brick walls were not connected at the four corners of the Test House. This was to ensure that the ultimate inertia load effect of the out-of-plane walls would be fully imposed on the ties. As testing was performed in both directions, each veneer wall could be treated as one specimen, and the geometric configurations would be equivalent to testing three (3) different cases: walls with no opening, wall with a window opening and a wall with a door opening. A plan of the Test House is shown in Figure 1a and Figure 1b shows the completed Test House.
