Making URM buildings safer in provincial towns - Cost-effective earthquake solutions

Abstract

Keywords: URM Seismic retrofit, Strong-backs, Mechanical Anchors, Shake table testing

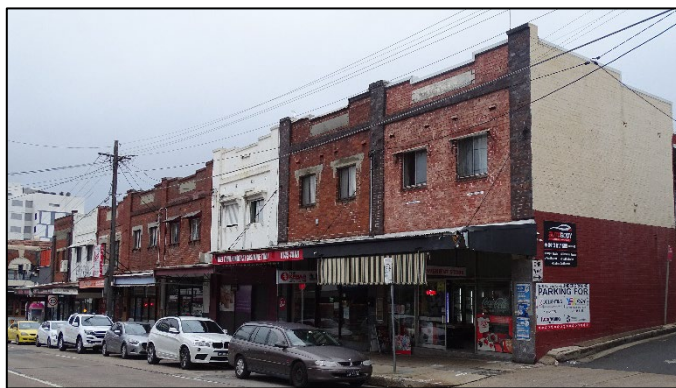
(a) Typical row buildings in Australia

Figure 1: Example of typical building typology and replicated building model

Two quarter-scaled clay-brick URM building models were constructed as representative of the common vintage commercial two-storey row buildings with multiple occupancies in New Zealand (URM building typology D, [17]) and Australia, see **Figure 1a**. The building consisted of a symmetrical opening configuration on the front façade with a large shop window at the ground floor and two smaller windows at the first floor see **Figure 1b**), and an asymmetrical opening configuration at the back façade with a door at the ground floor and two windows at the first floor. One of the side walls had two asymmetrical windows at the top floor (see **Figure 1b**) suggesting that the model was representative of an end-row building. General building and model dimensions are presented in **Table 1**. The first building model was tested in as-built conditions with wall-to-diaphragm (w-to-d) anchorages while the second building model was tested in retrofitted condition. The retrofits were designed to be cost-effective and to be easily implement and removed if needed. Reversibility of the retrofit interventions is desirable for existing buildings as it enables eventual removal of the retrofits for more aesthetic or advanced replacement solutions without damaging the original masonry fabric.

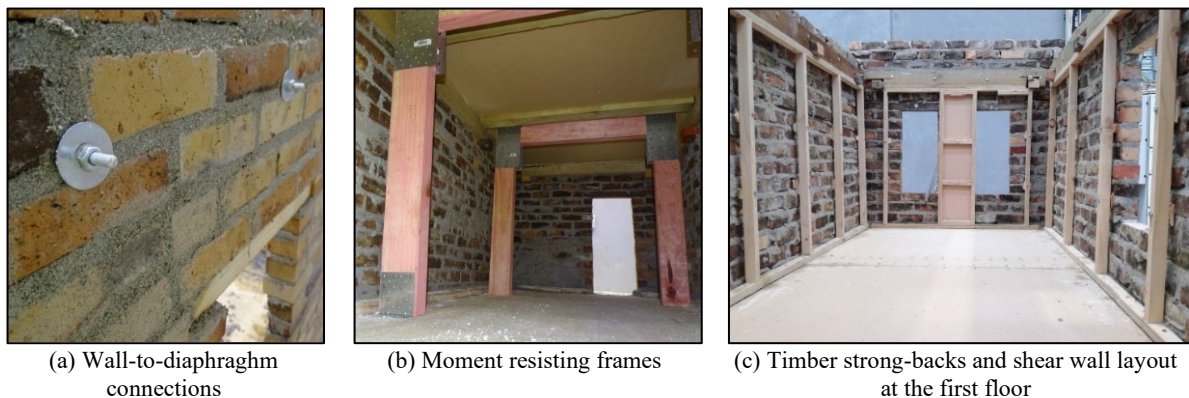
Figure 2: Retrofitted building model scheme

To ensure a box-type behavior and avoid cantilever wall collapse, a minimal level of retrofit was installed in the as-built model and consisted of wall-to-diaphragm connections at both floor and roof level as founded in many existing buildings. The connections were realised by bolting the timber floor section to the wall through the mortar joints, see **Figure 2a**.

In addition to the wall-to-diaphragm connections (see **Figure 2a**), two moment-resisting frames (MRF) were placed on the ground floor of the retrofitted model, as shown in **Figure 2b**, to resist the majority of the flexural demand. The MRF were composed of equally spaced 75 mm x 50 mm timber sections, and were screwed into the MDF floor board above and also the shake-table base below. Lateral load would transfer from the wall, through the floor, into the frames, and then finally into the shake-table base.

On the top floor, 18 mm x 25 mm timber strong-backs replicating the cost-effective technique proposed in [23] were installed as shown in **Figure 2c**. The top and bottom sections of the timber strong backs were screwed into the roof and floor respectively, to enable load path transfer from the diaphragms to the walls. Each vertical strong-back member was then bolted into the wall to create a composite action reducing the risk of out-of-plane collapses in the top storey. Shear walls composed of 6 mm MDF board were introduced on the in-plane walls and bolted to the piers, see **Figure 2c**, to reduce the rocking demand of the piers at the first floor characterised by high aspect ratio and low axial load.

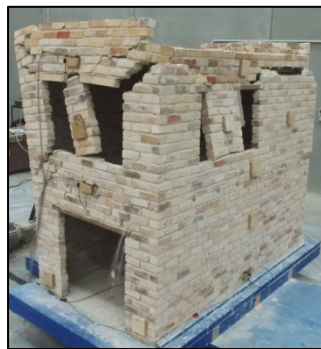
(a) Front façade and right-side wall

Figure 5: As-built building model at near-collapse, 0.56g

Collapse – As the acceleration increased, two-way bending crack-patterns appeared at the lower storey of the left-side wall, see **Figure 5b**. As the acceleration reached approximately 0.56g, two large cracks extending from the upper and lower corners of the front-right window caused the whole section of the right-side wall to separate from the structure, see **Figure 5a**. The upper-storey showed a clear two-way bending followed by full collapse, while the lower storey was standing and showing extensive cracks.

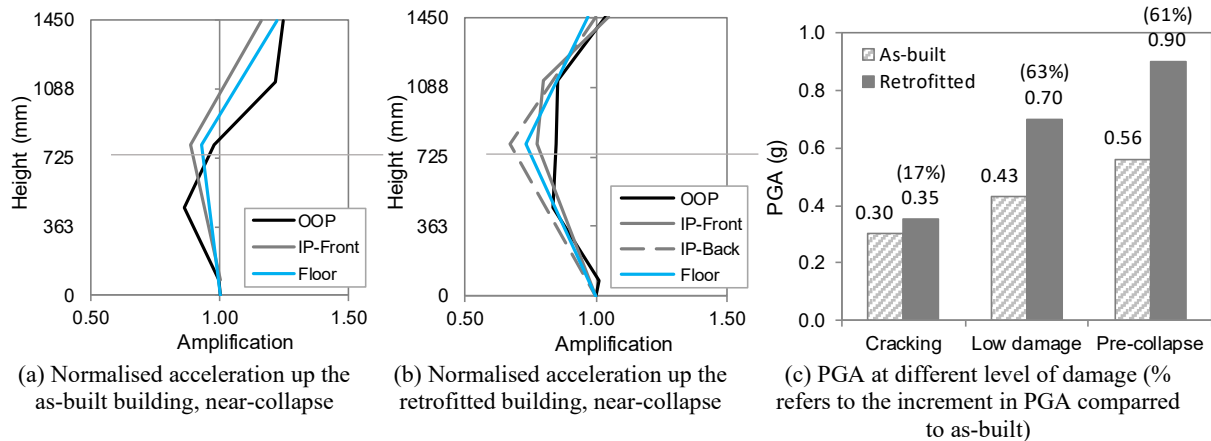
Figure 8: Acceleration comparison between models

Figure 8a,b shows acceleration profiles along the building height, normalised with respect to the peak ground acceleration (PGA) measured on the table. Data is shown at several locations, for both the as-built and retrofitted models. **Figure 8c** compares the PGA recorded at different level of damage above described and shows in brackets the percentage of acceleration increment between as built and retrofitted models. The maximum recorded roof displacement measured at mid-span of the left-side wall was 56 mm and 44 mm for as-built and retrofitted models respectively. After completion of testing, the retrofitted model presented a residual 18 mm displacement toward the left-side wall.
