Behavior of traditional timber frames under reverse-cyclic loading

ABSTRACT: Traditional timber frames in Turkey especially the ones in Safranbolu region consist of several configurations and several infill materials. The configurations include simple frames and braced frames. The infill materials include adobe, stone, brick or wood. Although the frames have a wide variety they do not have specific calculations and design rules. They were designed according to the knowledge and experience of the skilled workers. Therefore, the behaviour depends on workmanship too much. In this study two full scale timber frames of yellow pine and fir were prepared considering the abovementioned discussions. Each frame have the same geometry. They are both 3.3 m high and 3.6 m wide. They do not include any openings. Frames have nailed connections and prepared by the skilled workers. Tests were performed both on bare frames and frames with infills. The yellow pine frame had adobe infill whereas the fir one had wood laths nailed to the timber framing called "şamdolma". Results of the tests revealed that energy is dissipated at the connections. Both infills increased the strength.

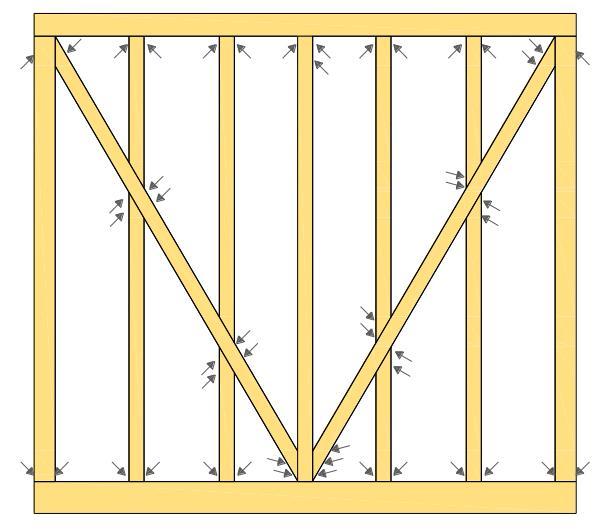
a) Yellow pine

Two test frames were built according to the real examples available in Safranbolu. One of the frames is built from yellow pine and the other from fir. Both frames have the same geometry as shown in Figure 1. They are both 3.3 m high and 3.6 m wide. They do not include any openings. Frames have nailed connections on which the number and orientation of nails are also given in Figure 1.
