Mine blasting vibration and its effects on buildings and structures – implementing a frequency-based approach

Bill Jordan

Bill Jordan & Associates Pty Ltd, Newcastle NSW. Email: bill@bjaeng.com.au

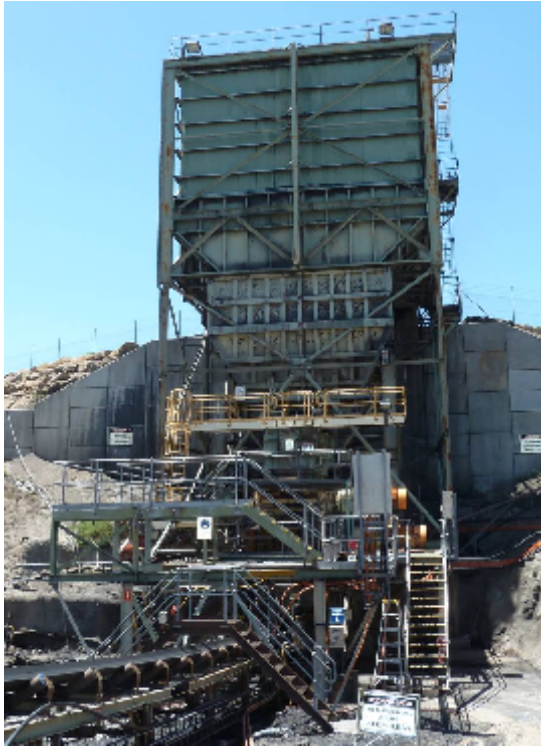
Figure 1: Geophones were placed on the ground at the base, at dump level (top of the retaining wall) and at the top of the structure.

Triaxial geophones, measuring in velocity units, were set up on rock beside the base of the structure, at the top of the bin and on top of the dust hood. The structure is shown in figure 1.
