“On Construction in Earthquake Countries.”

By JOHN MILNE, F.G.S., Professor of Mining and Geology,  
Imperial College of Engineering, Tôkiô, Japan.

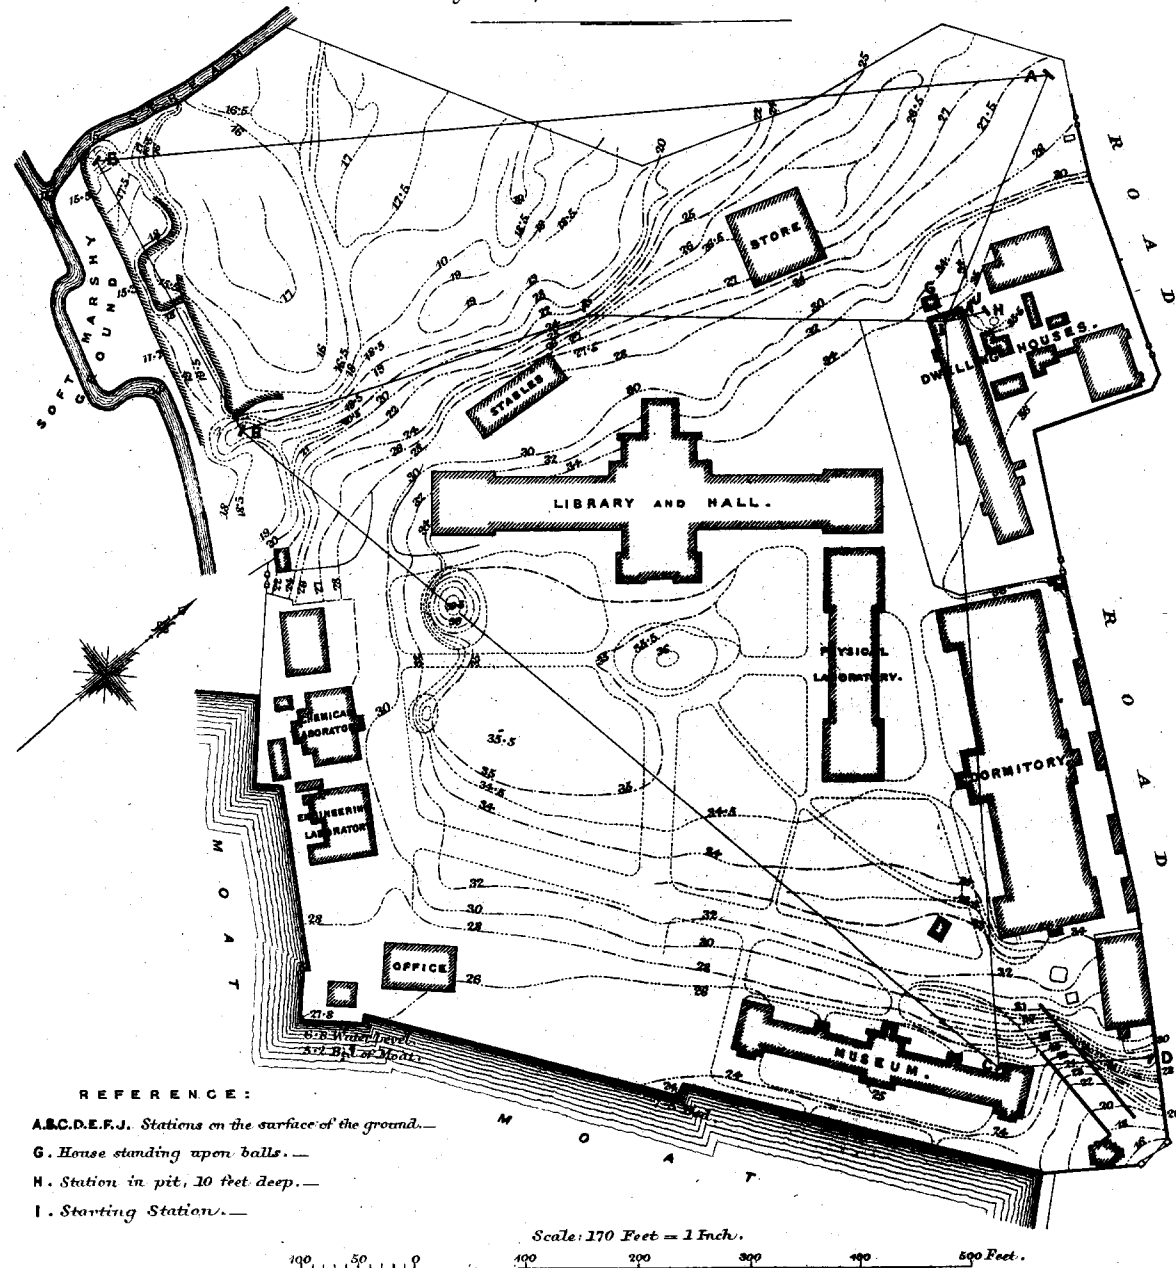
GROUNDS OF THE IMPERIAL COLLEGE OF ENGINEERING,  
TOKIO, 1885.

Shewing Earthquake Stations and Contour Lines.

REFERENCE:  
A,B,C,D,E,F,J. Stations on the surface of the ground.—  
G. House standing upon balls.—  
H. Station in pit, 10 feet deep.—  
I. Starting Station.—

Scale: 170 Feet = 1 Inch.

*Seismic Survey.*—During the last eighteen months the Author has had at and near his house a series of earthquake-stations, none of which were more than 800 feet apart. The instruments at these different stations were all placed in similar positions, and fixed on the heads of stakes level with the surface of the ground. The depth to which the stakes were driven was about 3 feet. When these instruments are placed side by side they give results practically similar. To reduce whatever slight errors might have been due to the instruments, they have been, from time to time, exchanged between the different stations. Four instruments have been placed on soft ground; one is within a few feet of marshy ground; another, also on soft ground, is at the foot of a slope about 6 feet high, rising up to ground which is hard and solid. The remaining stations, with the exception of one which is in a pit, are situated on high, dry ground, upon which there are several heavy brick structures. At the time of an earthquake a pendulum is set free to swing across a cup of mercury. At each contact with the mercury a current from thirty-three Daniel cells is sent to each of the stations. At the first contact the current sets in motion at each of them a carriage carrying a smoked-glass plate, upon which the seismograph writes. At every subsequent contact a mark is made upon the moving plate. By this means it is possible, so far as time is concerned, to institute the most minute comparison between the records given at each station. The smoked plates with their records are subsequently varnished and then photographed. As a general statement of the results which have been obtained by these investigations, it may be said that had different observers been placed in this small area, which is only 10 acres in extent, each would have given a totally different account of the same earthquake, both as to direction, amplitude, period, maximum velocity, and intensity. The actual results obtained for a few of the earthquakes which have been recorded are given in Tables in the Appendix, where A, B, C, D, E, F, G, H, and J, refer to different stations. A, B, E, and F are situated on soft ground. C, D, and J are on hard and relatively high ground. G represents

the records taken in a house of peculiar construction, and H is the station in a pit. Whether as regards the average results, or particular earthquakes, it will be found that both in regard to the projecting power as measured by the maximum velocity, or the overturning and shattering power as measured by maximum acceleration, relatively high and hard ground is much more suitable as a site for building than soft ground.

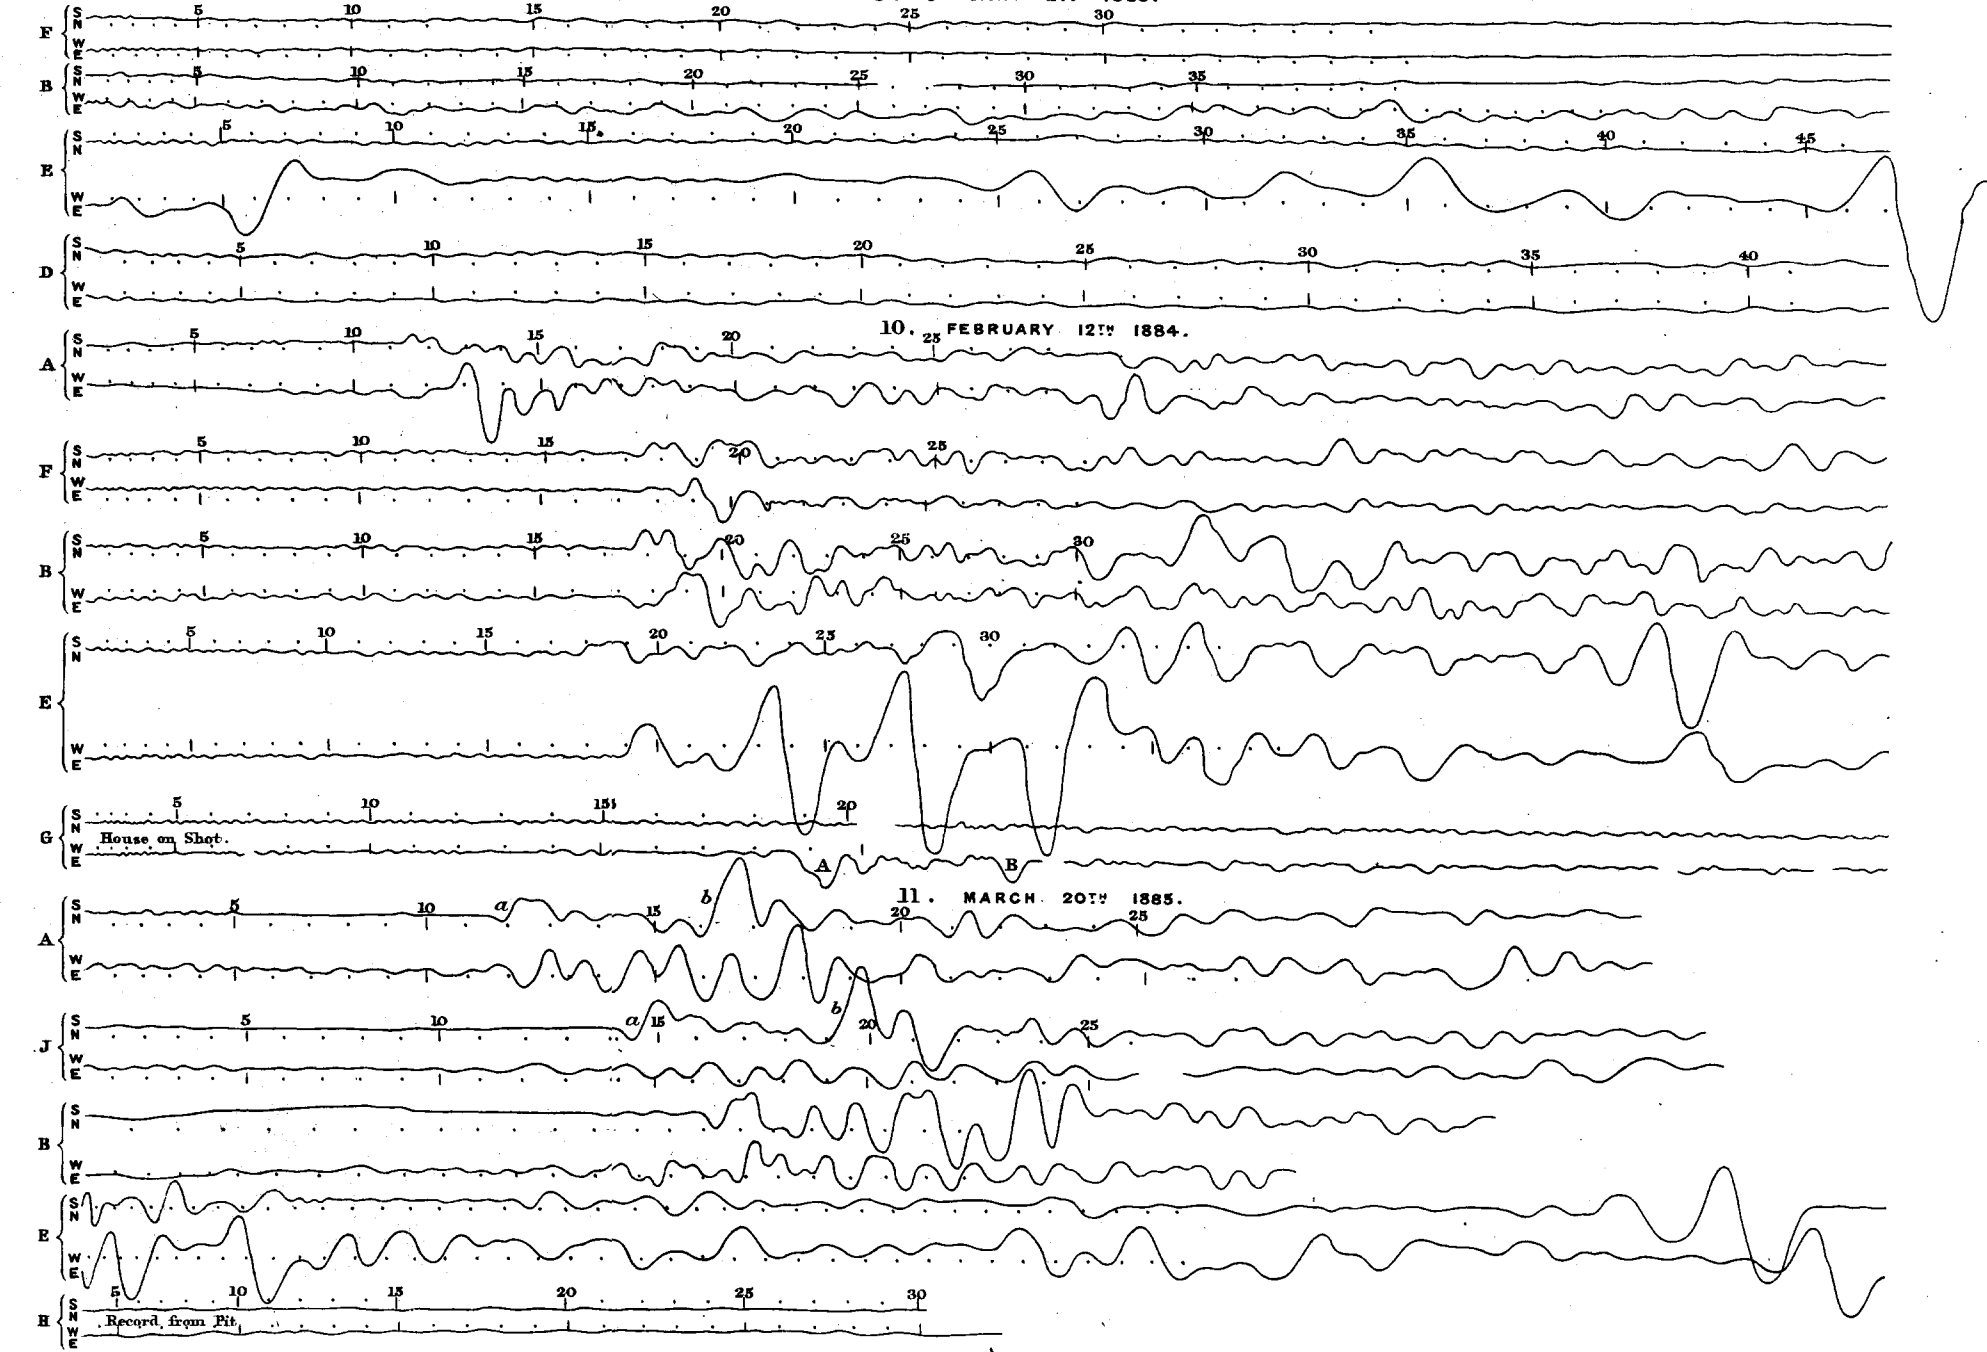
TIME INTERVALS = .366 SECOND.  
9. JANUARY 2<sup>nd</sup> 1885.

The general result obtained from this experiment has shown that at the bottom of the pit motion is always very small. Five different earthquakes have now been recorded in the pit, and the instrument has always been in good working order. In the diagram of the earthquake of the 20th of March, 1885 (Plate 3), which was tolerably strong, it will be seen that the record of the motion in the pit was almost invisible, while that recorded at J, about 20 feet distant, was as 1 to 43. The maximum velocity at these two points was as 1 to 52, and the maximum acceleration as 1 to 82.<sup>1</sup> The importance of this discovery to those who have to build in countries subject to earthquake is obvious. It is the Author's intention to make comparisons between a solid foundation rising freely in a pit, a similar foundation connected with the sides of the pit by brushwood and a covering of earth, and an ordinary foundation. To these may be added experiments on the isolation of a piece of ground by means of excavations.
