# Induced building vibrations — can we calculate responses?

**Bill Jordan.**

Bill Jordan & Associates Pty Ltd, Newcastle NSW 2300

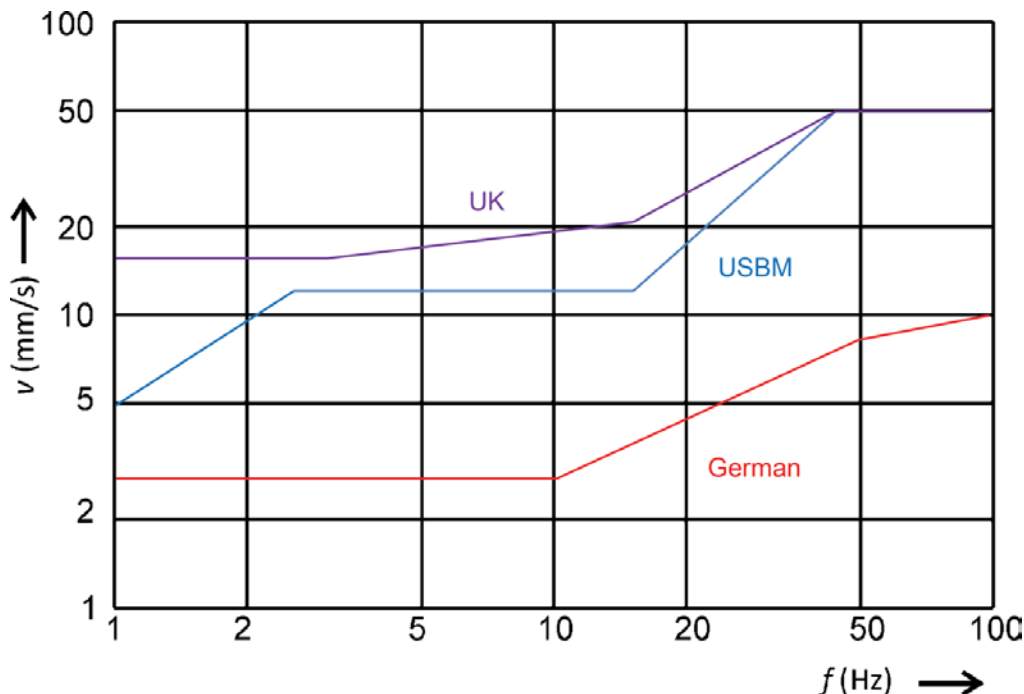
Figure 1: Comparison of frequencies v. PPV for some commonly quoted standards

It is helpful to compare the frequency-based ground vibration standards existing elsewhere in the world. Figure 1 compares the most frequently quoted (BSI, 1993; USBM, 1980; DIN, 1999).

What they all have in common is an increase in allowable PPV with frequency, but little information can be found to explain the differences both in level and frequency. In the past, consent authorities in N.S.W. have looked at the lowest PPV levels independently of frequency when setting limits for historical buildings. Near urban areas, limits for ground vibration and air blast appear to be set purely on human perception criteria to limit complaints.

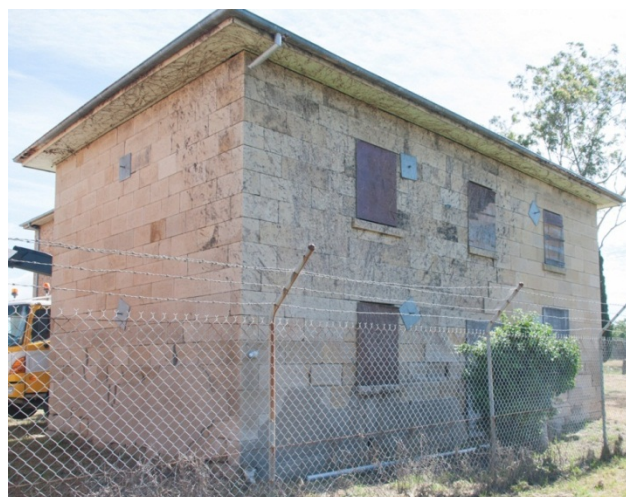
Figure 2: Building considered for comparison of frequency calculation methods

The author has been monitoring a group of 1840s buildings in the NSW Hunter Valley for some years and one of these is an ideal candidate to look at the differences in natural frequency estimation. The building is basically in ruins with the original first floor and roof having collapsed following termite damage. A new roof has been constructed to give some protection against further deterioration: the new roof is supported on the side and end walls, plus some internal steel columns from the ground to the ridge. Some light steel rods have been inserted between the walls, but these are loose and do not change the behaviour of the building at the low levels of vibration displacement concerned. The building is illustrated in figure 2.

As there is no first floor, it might be expected that out-of-plane flexure of whole wall panels might occur and both the top centre of the long walls and the wall centre at the former first floor level were monitored at different times, but added no useful knowledge. The building is 10.2 m long  $\times$  5.9 m wide and the top of the walls is 5.2 m above ground level, which is effectively the structural base.
