Seismic Risk Assessment of Residential RCC Buildings with Street Survey in Urban Areas of Developing Countries

Sania Tariq ¹, Shughla Ismail ², Majid Ali ³

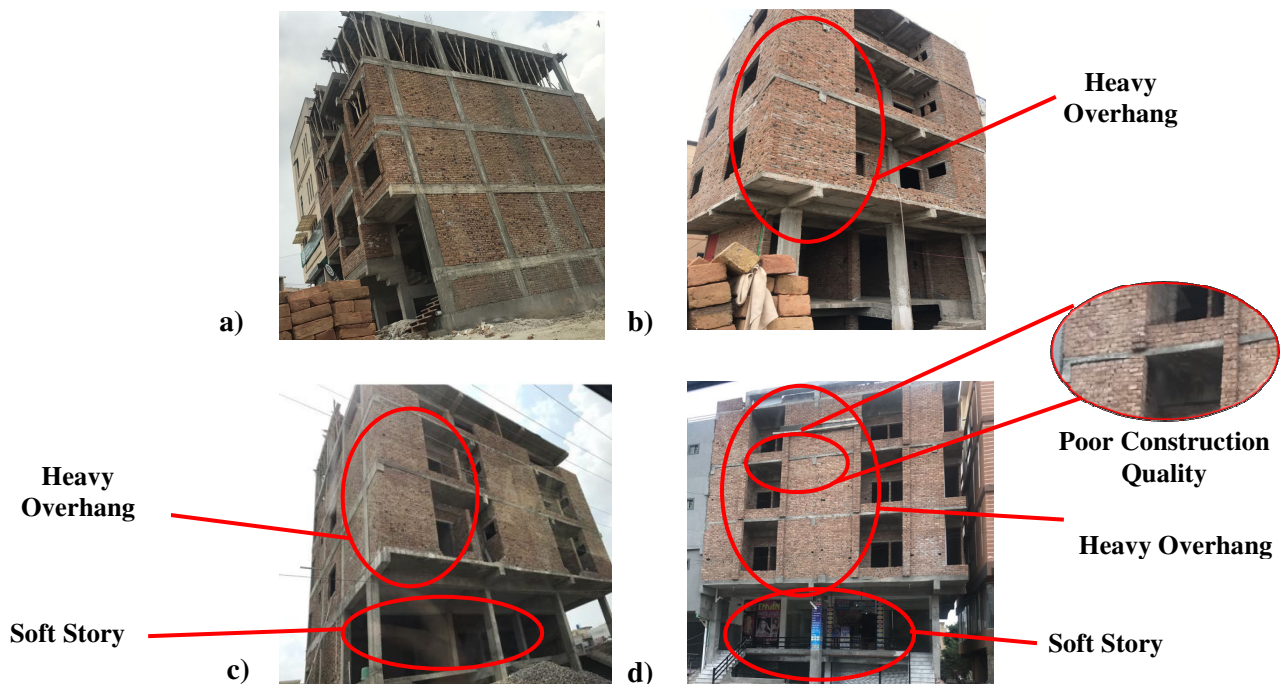
Figure 2: RCC Structures: a) at no risk, b) at low risk, c) at moderate risk, and d) at high risk

Figure 2 represents the four types of buildings observed i.e. at no, low, moderate and high risk. The common parameter observed in all four types is presence of heavy overhang. Low risk structures (Figure 2a) depicts good construction quality with strong beam-column joints.

Semi-buried basements and mid-story beams around stairway shafts lead to the formation of short columns in most concrete buildings which is observed in mostly moderate and high risk structures (Figures 2c and 2d). In high risk structures poor construction quality and weak beam-column joints are observed. The proper location and width of safe exit is ignored in moderate and high risk buildings. It is also noted that there is absence of emergency exit in all grey structures. However, there is a chance that a steel staircase may be provided after completion of civil works.
